# *Report to the President*

## **PRESIDENTIAL COMMISSION**

*on the Space Shuttle  
Challenger Accident*

June 6th, 1986  
Washington, D.C.

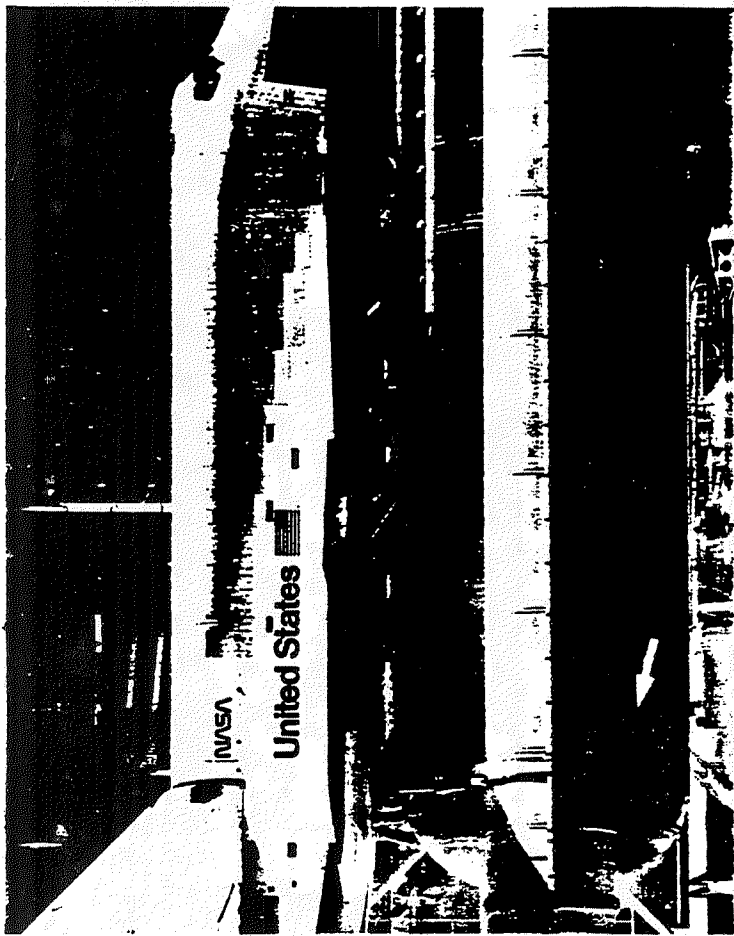
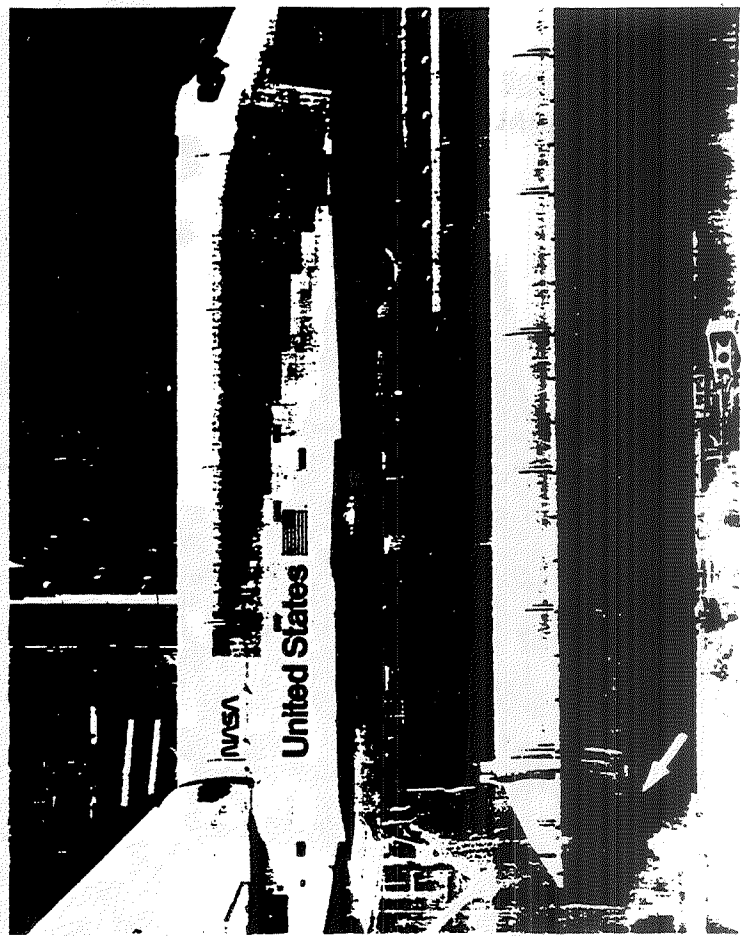
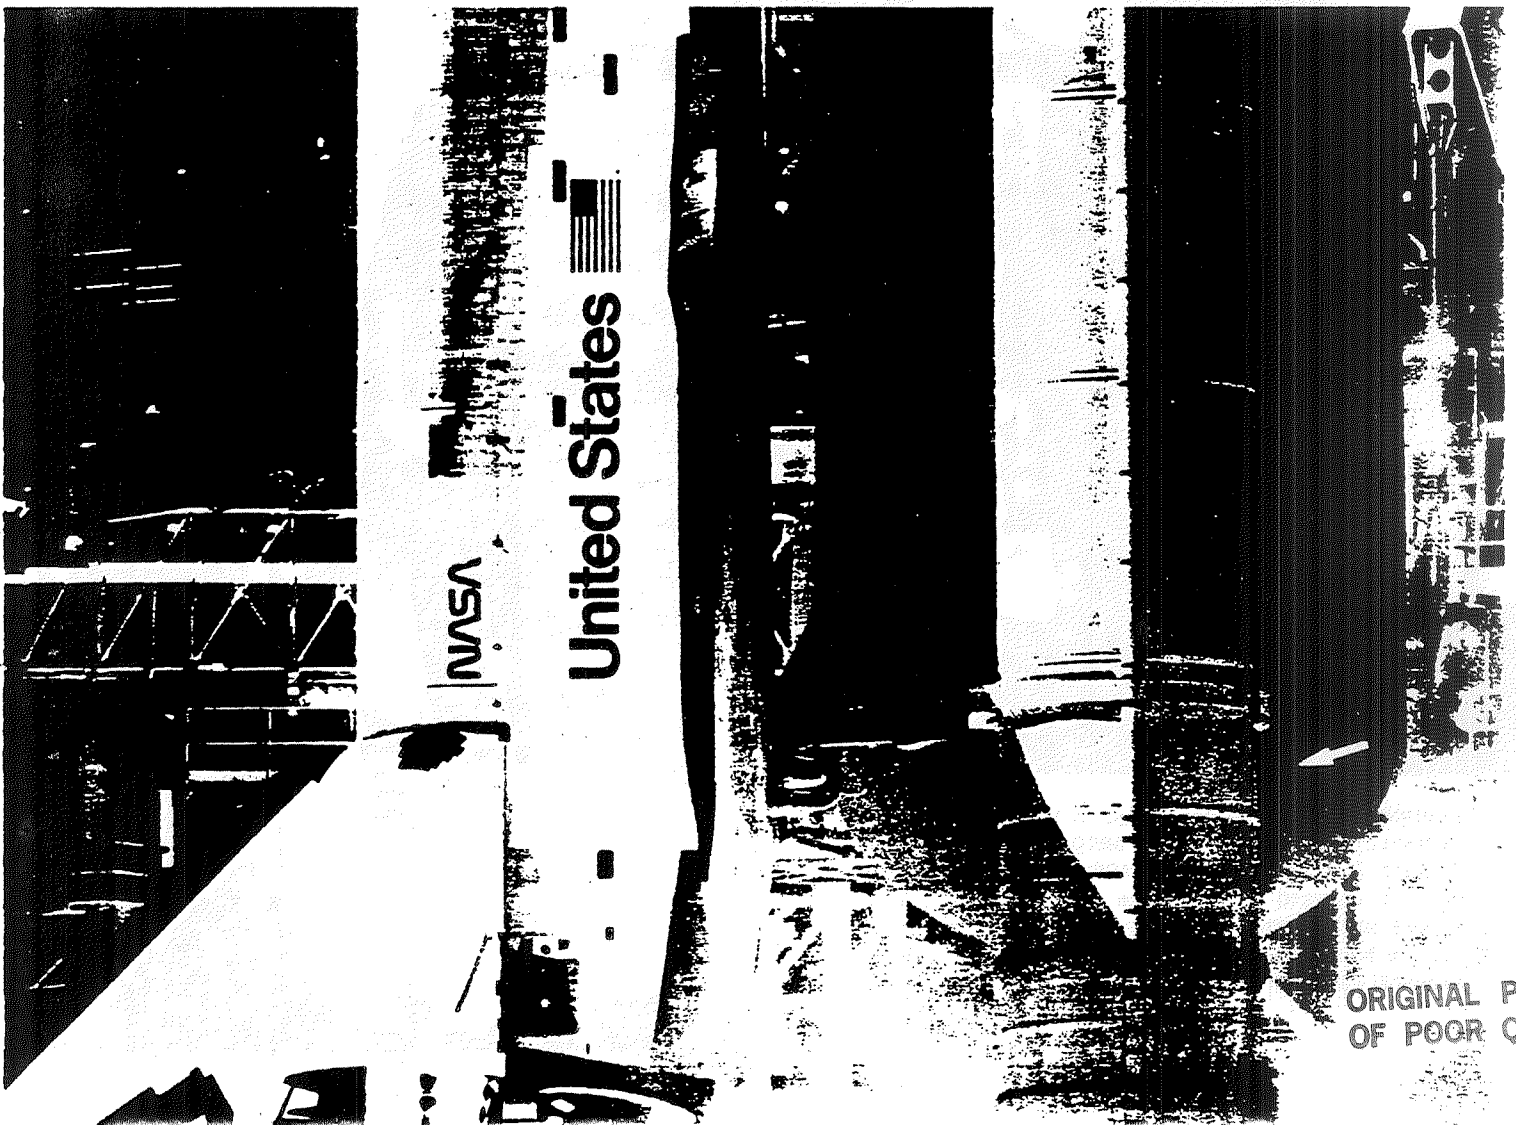
The black color and dense composition of the smoke puffs suggest that the grease, joint insulation and rubber O-rings in the joint seal were being burned and eroded by the hot propellant gases.

Immediately after solid rocket motor ignition, dark smoke (arrows) swirled out between the right hand booster and the External Tank. The smoke's origin, behavior and duration was approximated by visual analysis and computer enhancement of film from five camera locations. Consensus: smoke was first discernible at .678 seconds Mission Elapsed Time in the vicinity of the right booster's aft field joint.

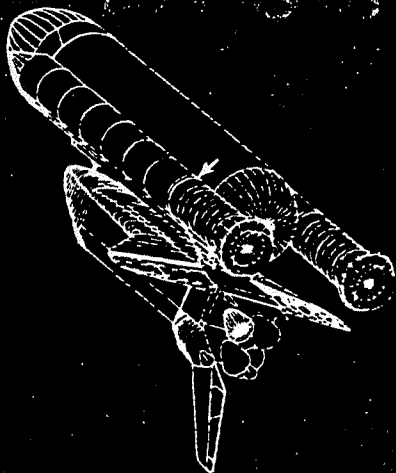
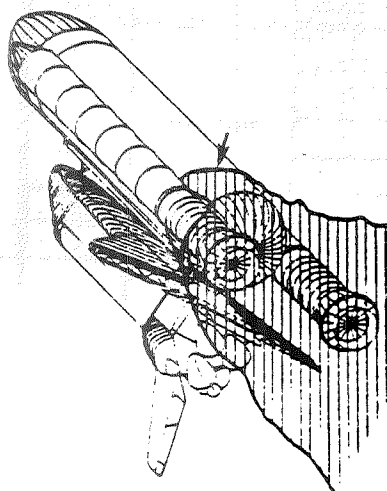
At 58.788 seconds, the first flicker of flame appeared. Barely visible above, it grew into a large plume and began to impinge on the External Tank at about 60 seconds. Flame is pinpointed in the computer drawing between the right booster and the tank, as in the case of earlier smoke puffs. At far right (arrow), vapor is seen escaping from the apparently breached External Tank.

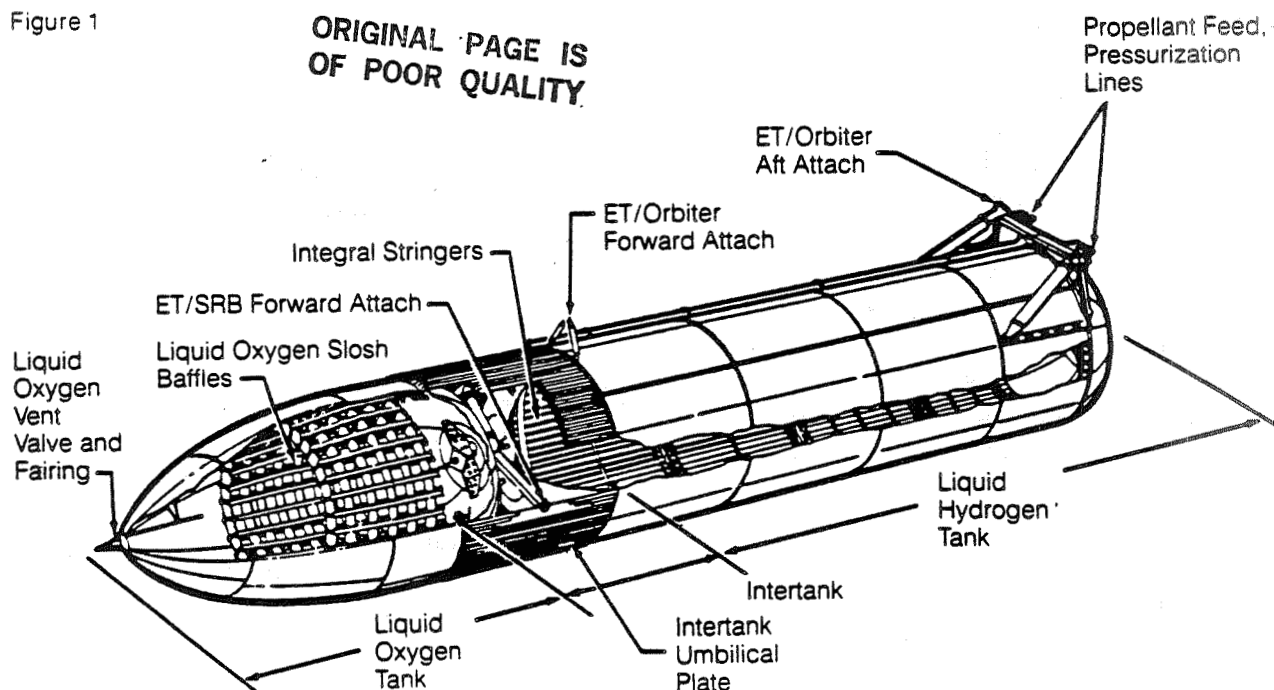
Figure 1

The possibility of an imperfection existing in either the pressurized or nonpressurized External Tank structural elements that could grow to a sufficient size to cause structural failure was examined in detail. All construction history, structural qualification test data, proof test inspection records and x-rays were reviewed. One previously

undetected imperfection that was discovered during a reexamination of the x-rays was found in recovered hardware with no propagation indicated.<sup>3</sup> Other data from the pre-launch ice and frost team inspections, film and video coverage, pressurization records and flight data revealed no evidence of leakage. The Commission concluded that no structural imperfections existed that could have grown to a size to create a leak or cause catastrophic failure of the External Tank.

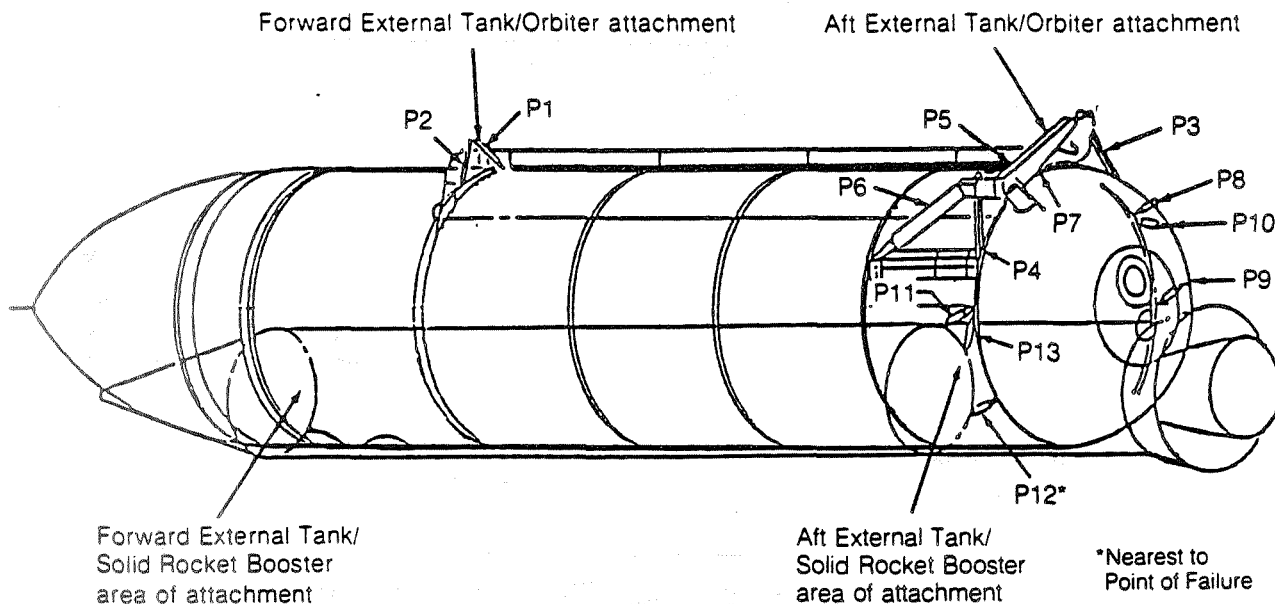
Figure 10  
Drawing of transparent External Tank, with right Solid Rocket Booster on far side, shows location of struts measured in table of strut loads. (Figure 9)

Engine thrust buildup, the resulting forces and moments, vehicle and pad stiffness, and clearances were as expected. The resultant total bending moment experienced by STS 51-L was  $291 \times 10^6$  inch-pounds, which is within the design allowable limit of  $347 \times 10^6$  inch-pounds.

The STS 51-L lift off loads were compared to design loads and flight measured loads for STS-1 through STS-7 (Figure 9). The Shuttle strut identification is shown in Figure 10. The loads measured on the struts are good indicators of stress since all loads between Shuttle elements are carried through the struts. The STS 51-L lift off loads were within the design limit.

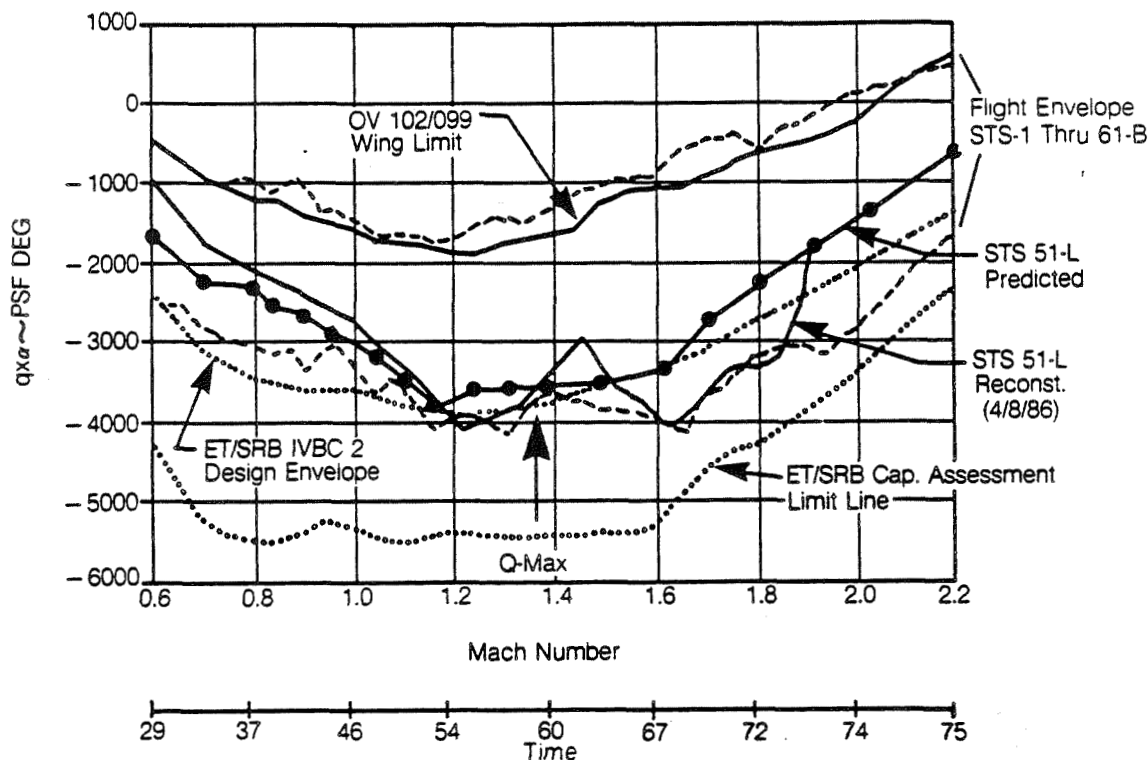
Figure 11

The Solid Rocket Motor field joint axial tension loads were substantially lower at maximum dynamic pressure than at lift off:  $11.6 \times 10^6$  pounds for the forward field joint and  $10.6 \times 10^6$  pounds for the aft field joint. Compared to the internal pressure loads, the dynamic variations due to wind shear were small—about  $\frac{1}{15}$  those of the pressure loads. *These loads were well below the design limit loads and were not considered the cause of the accident.*

The loads in the pitch plane are shown by the solid line marked "STS 51-L RECONST." The curve "STS 51-L PREDICTED" give the loads expected before the flight. The dashed lines show the limit of experience from STS-1 through 61-B. The present design limits are the two lines marked "OV

102/099 WING LIMIT" above, and "ET/SRB CAP. ASSESSMENT LIMIT LINE" below. (After STS-6, the wing was strengthened. The previous design limits were "ET/SRB IVBC 2 DESIGN ENVELOPE" below, and a curve in the positive region of  $q \times \alpha$  above)

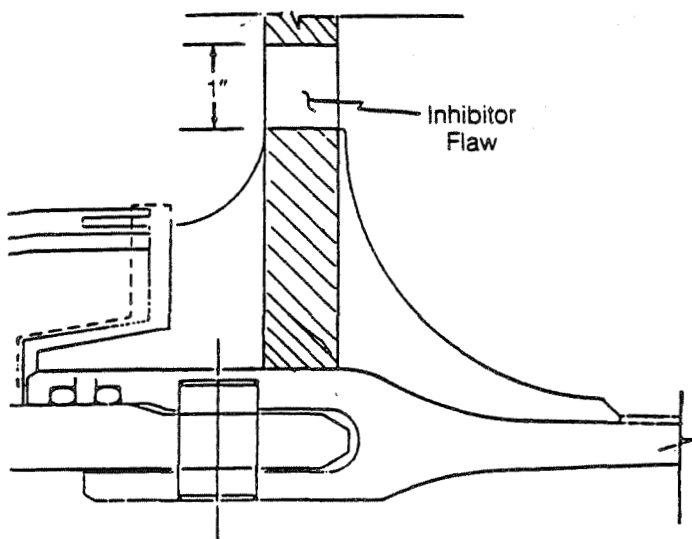
Figure 12

Sketch shows location of assumed inhibitor flaw used in eliminating such a problem as a possible cause.

Evaluation of potential insulation or inhibitor (see Figure 12) flaws against the three criteria above resulted in elimination of all candidates except a defect in the forward-facing inhibitor. This potential failure mode was evaluated by assuming a 1-inch-diameter hole in the inhibitor. Analysis indicated that the change in motor internal pressure resulting from this failure would probably not be detected. However, an erosion rate substantially higher than the observed values would be required to burn through the membrane by 58 seconds. In addition, the assumed flaw is unlikely since the inhibitor is constructed by vulcanizing eight individual plies of the material. Subsequent damage of the magnitude required is improbable and would be easily detected.

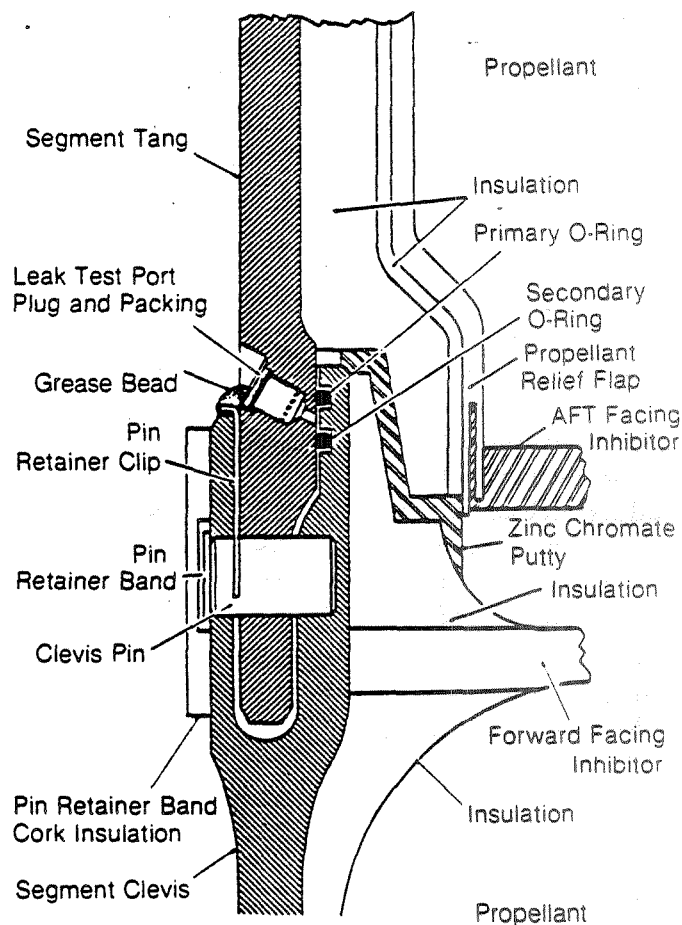
Figure 14  
Solid Rocket Motor cross section shows positions of tang, clevis and O-rings. Putty lines the joint on the side toward the propellant.

pressure loads are applied to the joint during ignition. Should pressure actuation be delayed to the extent that the gap has opened considerably, the possibility exists that the rocket's combustion gases will blow by the O-ring and damage or destroy the seals. The principal factor influencing the size of the gap opening is motor pressure; but, gap opening is also influenced by external loads and other joint dynamics. The investigation has shown that the joint sealing performance is sensitive to the following factors, either independently or in combination:

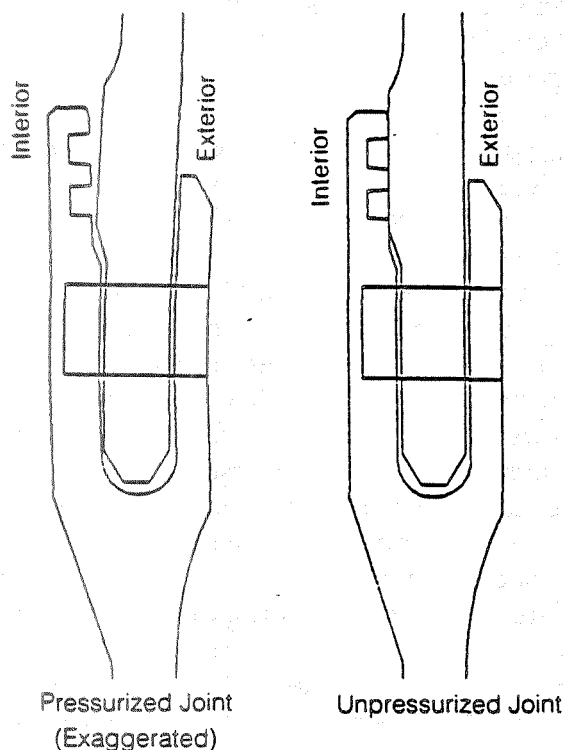
Figure 16

The joint deflection analysis established time histories for gap openings for primary and secondary O-rings for all field joints. For the aft field joints these data indicate gap opening increases of approximately 0.029 inches and 0.017 inches for the primary and secondary O-rings respectively. These values were used for sub-scale dynamic tests. Due to differences in motor pressure and loads, the gap opening increases for forward field joints are approximately 0.008 inches greater than for the aft field joints. Gap opening changes (called delta gap openings) versus time are shown in Figure 17 for the aft field joints. The total gap at any time also depends on the initial static gap, on rounding effects during segment pressurization, and on loadings due to struts and airloads. Sub-scale tests were run containing combinations of the above variables, but did not include the effects of the struts and airloads.

Drawings show how tang/clevis joint deflects during pressurization to open gap at location of O-ring slots. Inside of motor case and propellant are to left in sketches.

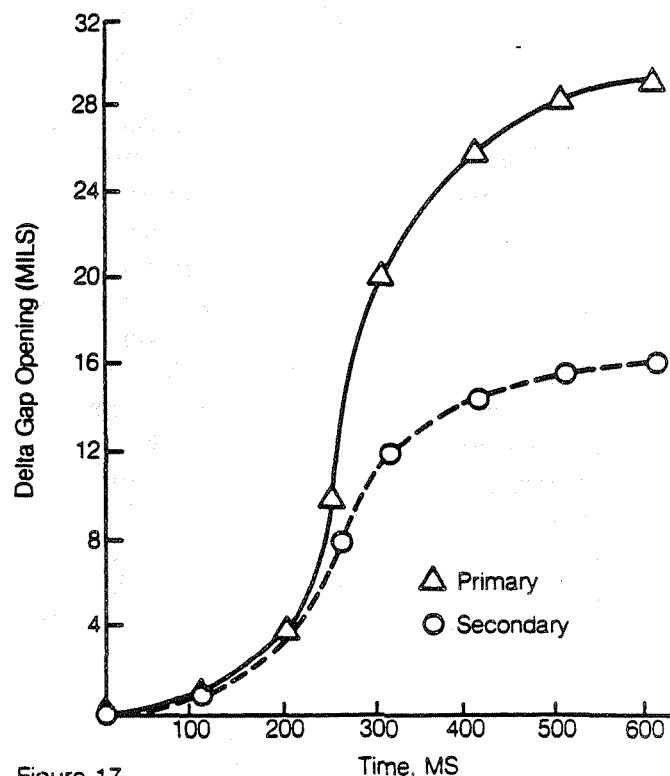
Figure 17

Graph plots changes in right booster's aft field joint primary and secondary gap openings. Horizontal scale is time in milliseconds from ignition.

Consistent results from numerous O-ring tests have shown a resiliency degradation with reduced temperatures. Figure 23 provides O-ring recovery from 0.040 inches of initial compression versus time. This shows how quickly an O-ring will move back towards its uncompressed shape at temperatures ranging from 10 to 75 degrees Fahrenheit. When these data are compared with the gap openings versus time from Figure 17, it can be seen that the O-rings will not track or

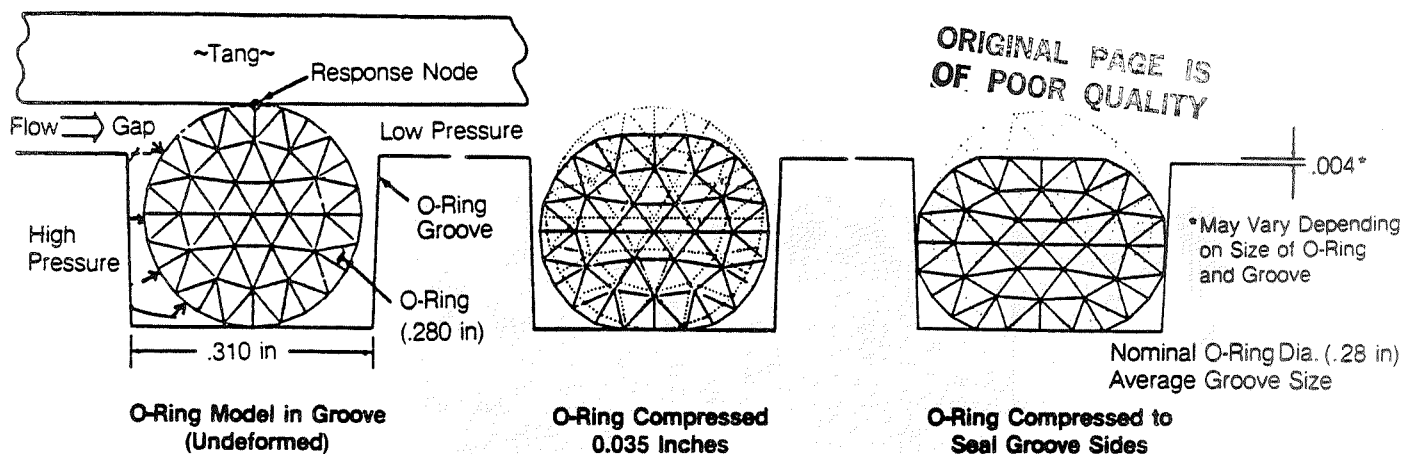
Figure 18  
Drawings show how progressive reduction of gap between tang and clevis can inhibit and eventually block motor cavity's high-pressure flow from getting behind O-ring.

Recent analysis has shown and tests tend to confirm that O-ring sealing performance is significantly improved when actuating pressure can get behind the entire face of the O-ring on the upstream side of the groove within which the O-ring sits (Figure 18). If the groove is too narrow or if the initial squeeze is so great as to compress the O-ring to the extent that it fills the entire groove and contacts all groove surfaces, pressure actuation of the seal could be inhibited. This latter condition is relieved as the joint gap opens and the O-ring attempts to return to its uncompressed shape. However, if the temperature is low, resiliency is severely reduced and the O-ring is very slow in returning towards its original shape. Thus, it may remain compressed in the

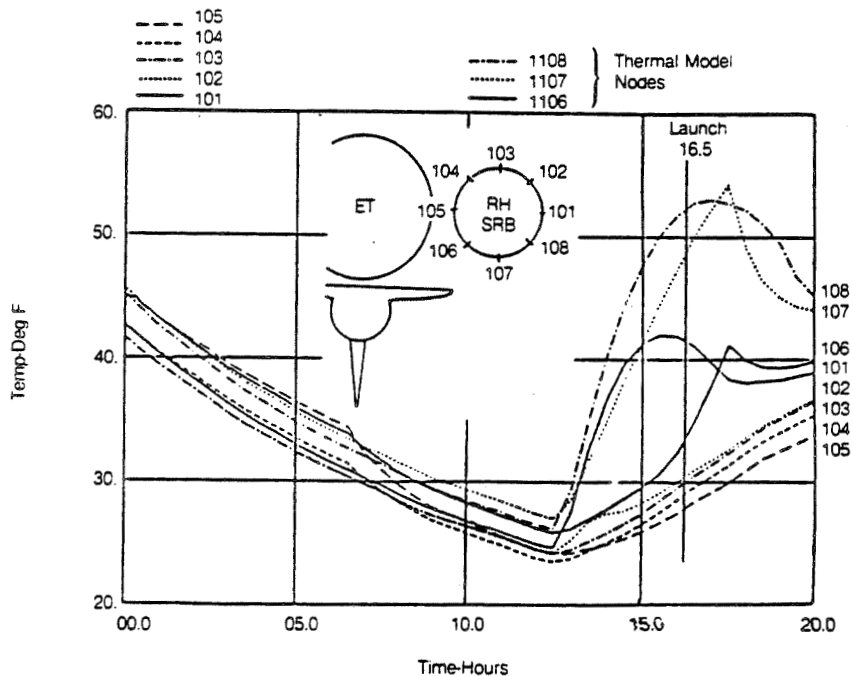
Figure 20

Temperature model for 51-L right solid booster aft segment circumferential positions from 16.5 hours prior to launch to 3.5 hours after launch.

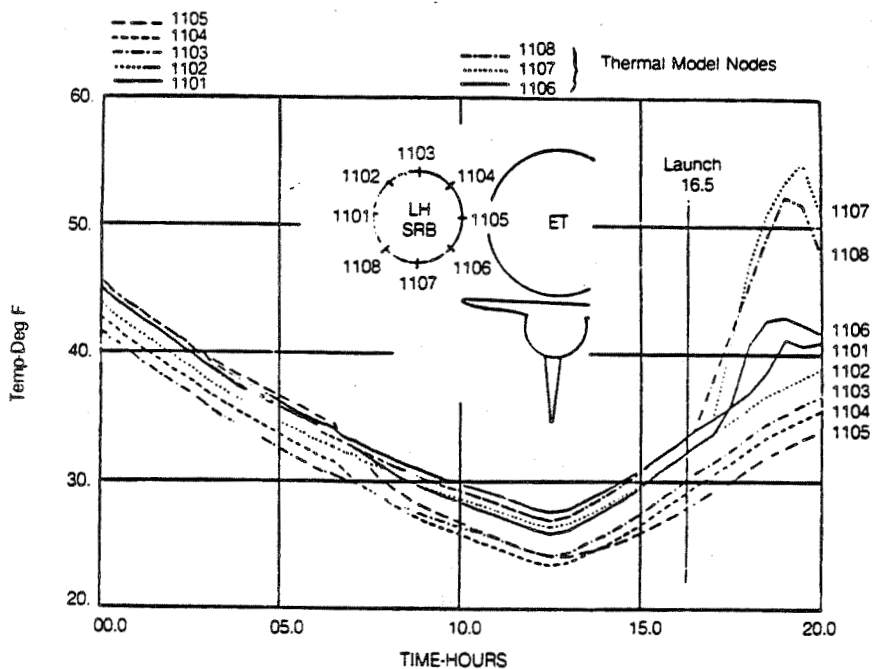
Figure 21

Temperature model for 51-L left solid booster aft segment circumferential positions from 16.5 hours prior to launch until 3.5 hours after launch.

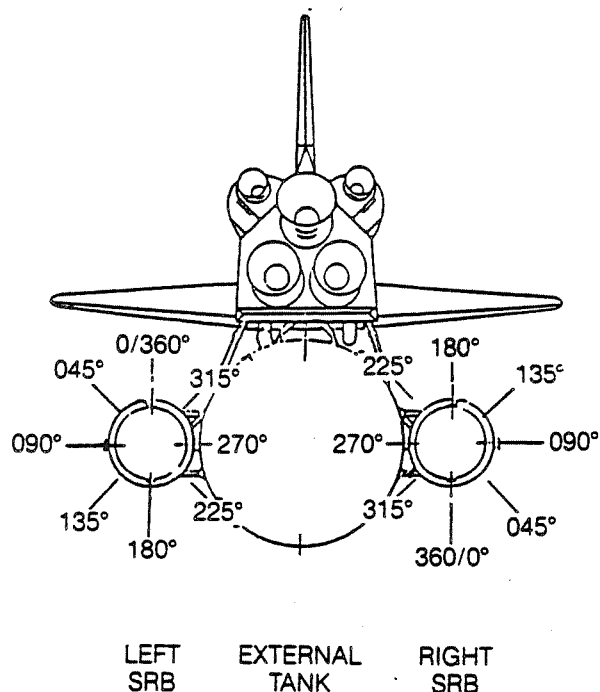
parts 131, the upper segment tang region, and part 712, the lower clevis region of the joint. This burned area extends roughly from station 1476, in the upper section, to 1517 on the lower region. In a circumferential direction (see figure 26) the lower end of the eroded region extends from roughly 291 degrees to 320 degrees and the upper eroded section extends between 296 and 318 degrees. Note that the region at about 314 degrees includes the attachment region of the strut to the attachment ring on the right Solid Rocket Booster.

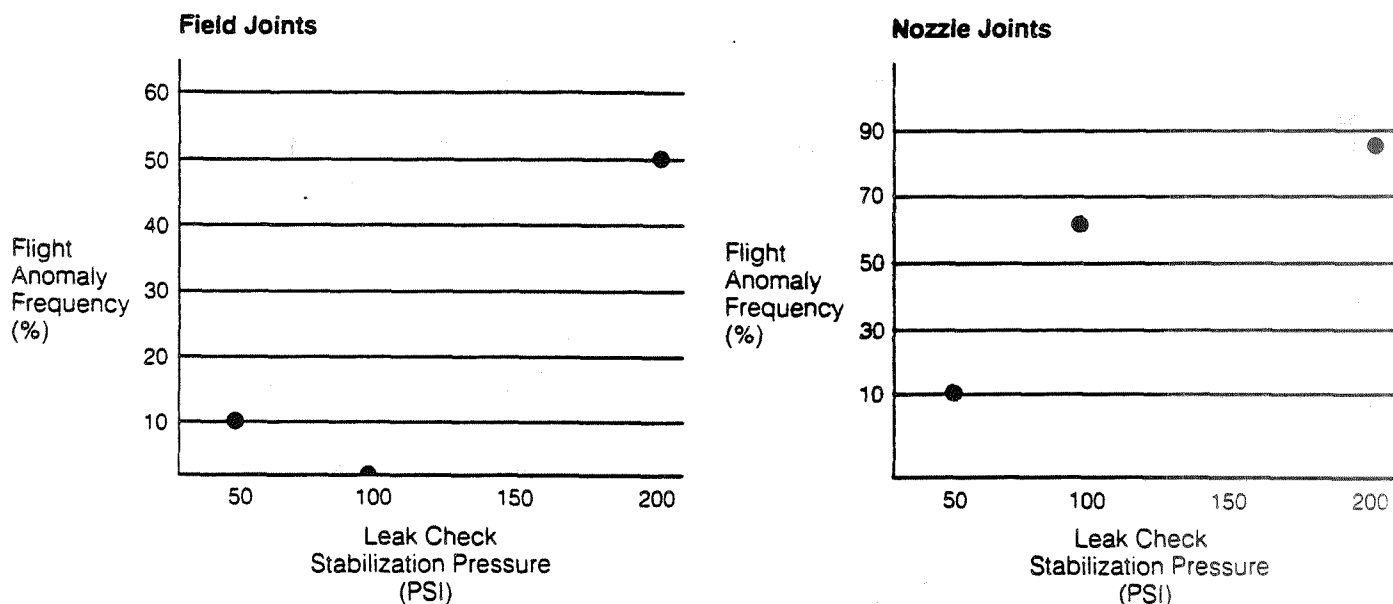
Graphs depict flight anomaly frequency for both field and nozzle joint of solid motors for a variety of leak check pressures. Figure 3

This hypothesis that O-ring erosion is related to putty blow holes is substantiated by the leak check history (Figure 3). Prior to January, 1984, and STS 41-B, when the leak check pressure was

The trends of flight anomalies in relation to leak check stabilization pressure are illustrated for the field joint and the nozzle joint in Figure 3, on page 133. While the data point concerning the 100 pound per square inch field joint leak check is not conclusive since it is based on only two flights, the trend is apparent.

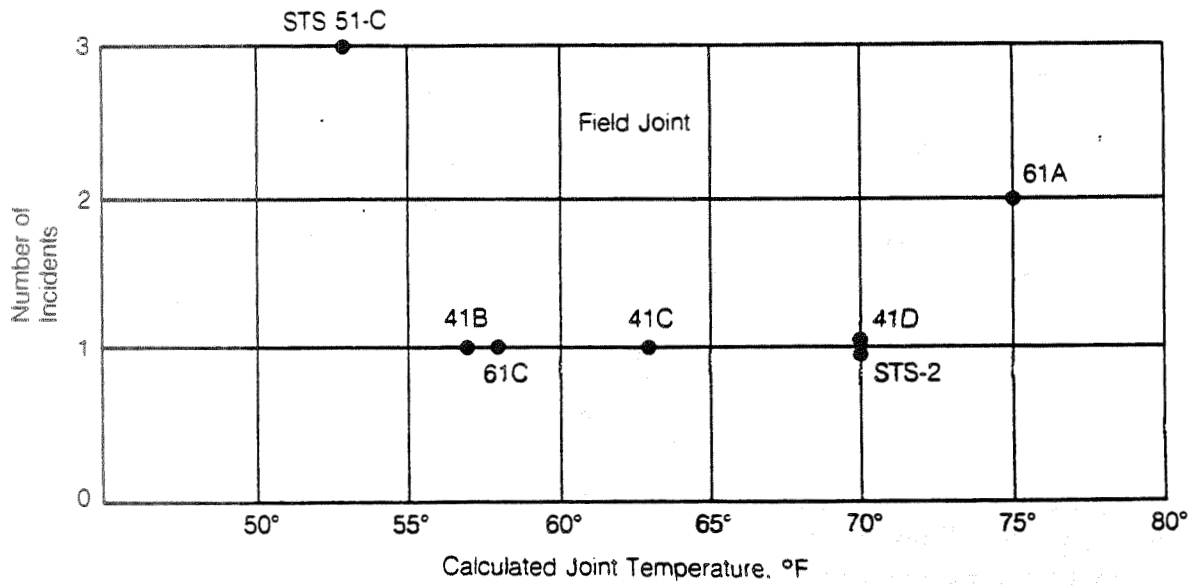
cy of occurrence based on all flights (Figure 6 ). In such a comparison, there is nothing irregular in the distribution of O-ring "distress" over the spectrum of joint temperatures at launch between 53 degrees Fahrenheit and 75 degrees Fahrenheit. When the entire history of flight experience is considered, including "normal" flights with no erosion or blow-by, the comparison is substantially different (Figure 7).

Figure 6  
Plot of flights with incidents of O-ring thermal distress as function of temperature

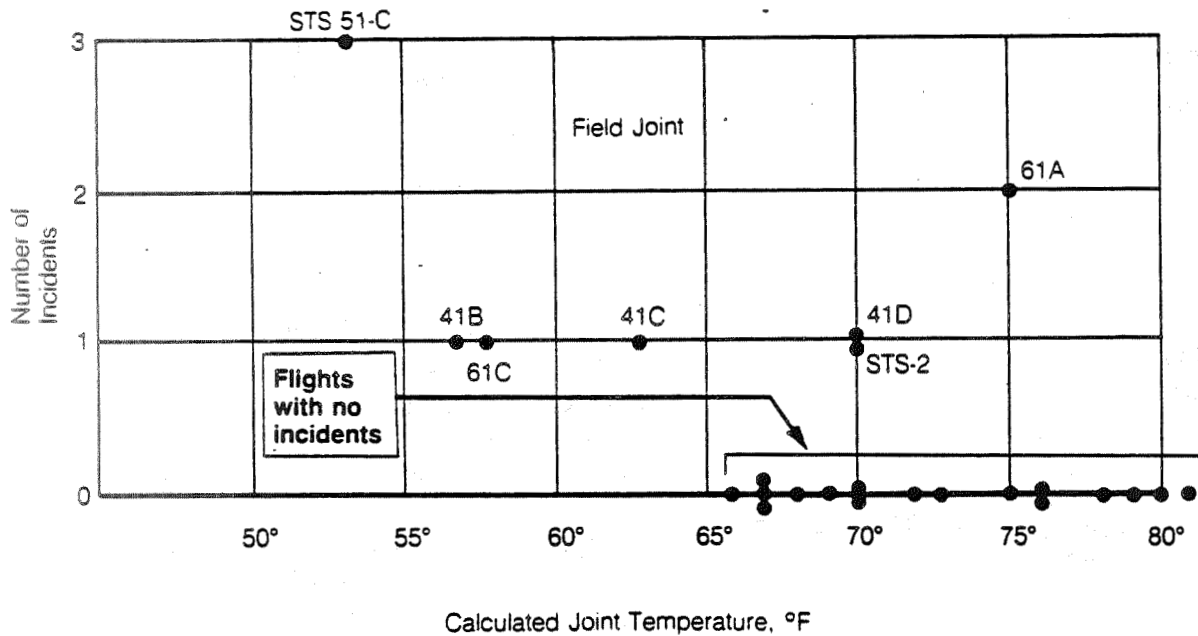
Figure 7  
Plot of flights with and without incidents of O-ring thermal distress

NOTE: Thermal distress defined as O-ring erosion, blow-by, or excessive heating

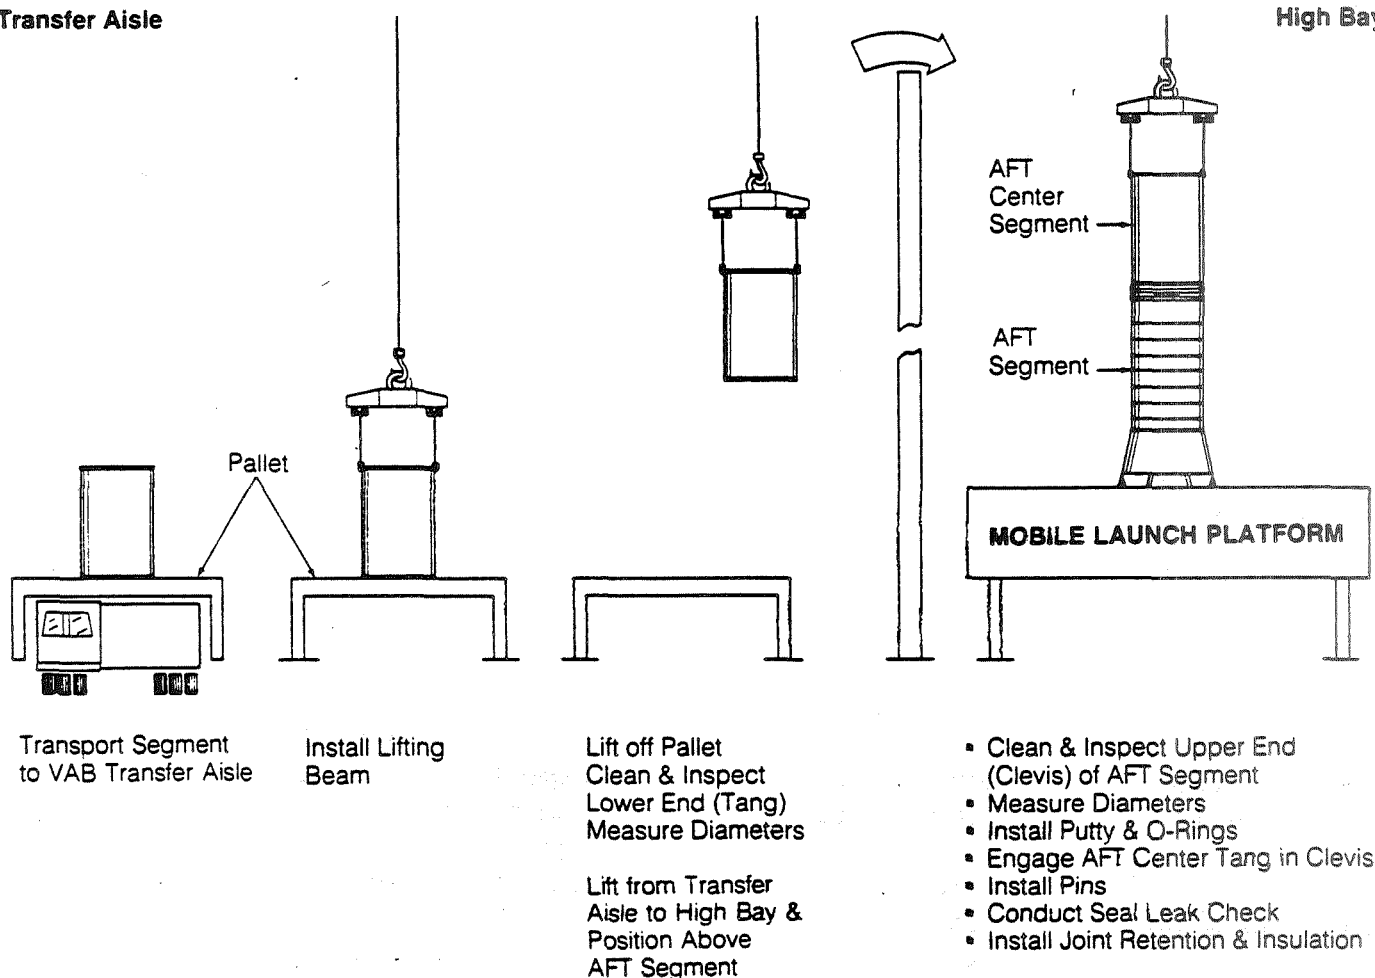
Drawing depicts steps in the stacking of the aft and aft center segments of the Solid Rocket Booster in the Vehicle Assembly Building (VAB).

stacking interference. Taken across the 0-180 degree axis, the tang diameter measurement exceeded the corresponding clevis dimension by +.512 inch. The maximum allowable tang to clevis difference is +.250 inch.
